**VISUAL TREE ASSESSMENT (VTA) AND WRITTEN REPORT**

**LOCATION: DALLEY STREET JUNEE**

**COMPLETED FOR: JUNEE SHIRE COUNCIL**

**DATE: MAY 2014**

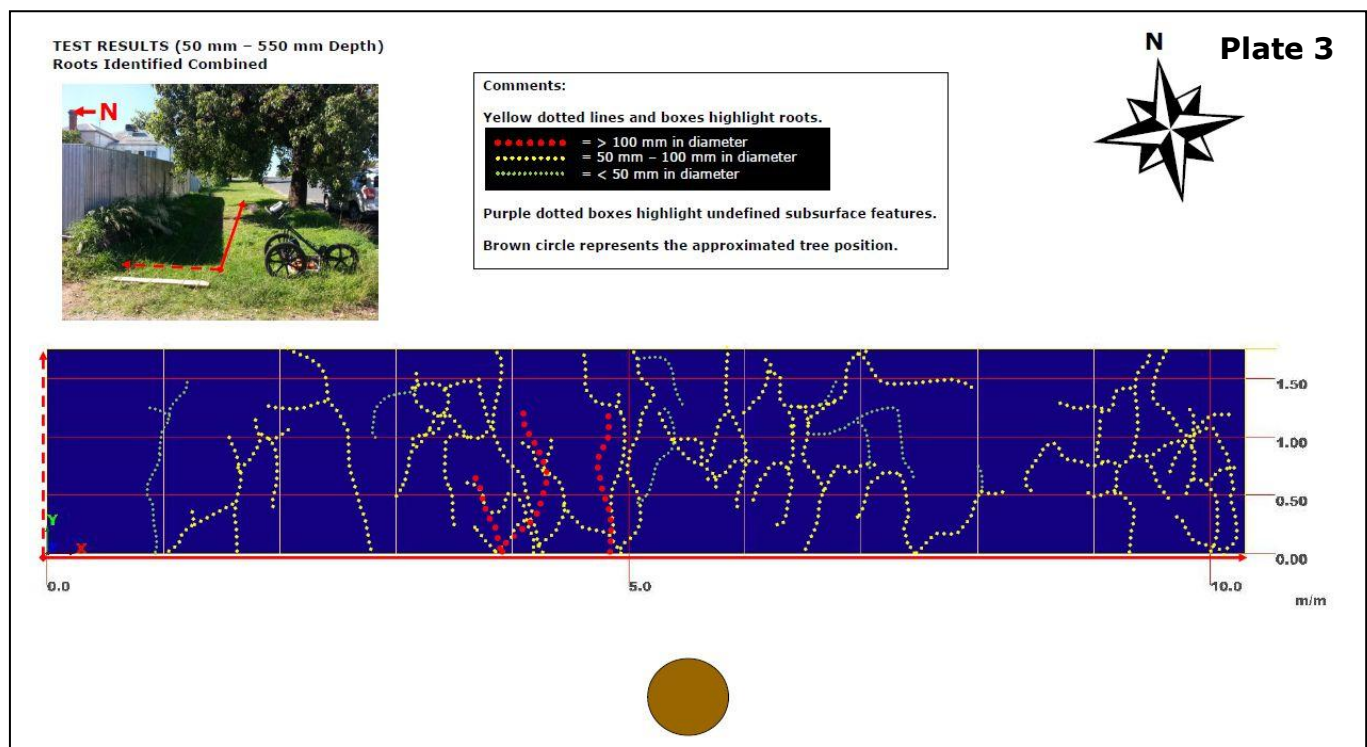
Plate 3 provides an example of the summary test findings within the upper soil profile north of Tree 1. All summary details of test findings within the upper soil profile for each tree have been provided in Appendix 1. All GPR test results have been provided as separate report Appendices.

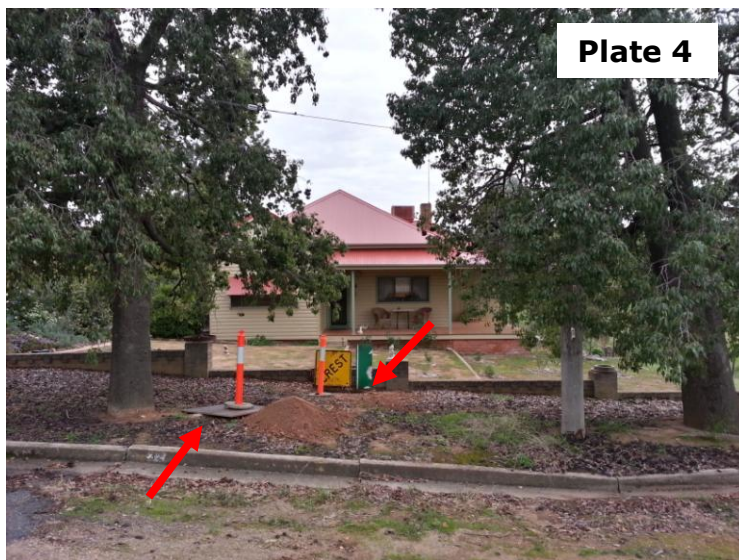
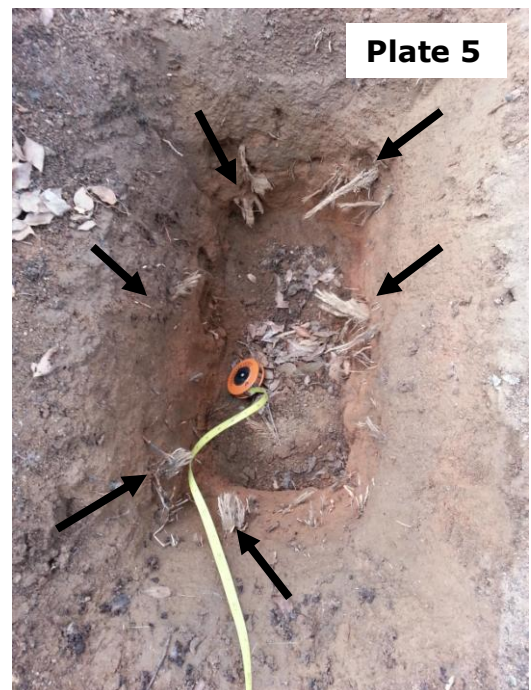
Several subsurface utilities were identified within the GPR tests; adjacent to Tree 5, 8, 9, 15, and 16. It was interpreted that roots would have been damaged and disturbed during the construction and maintenance of these subsurface utilities. No obvious signs of damage were evident for most trees, but symptoms of root damage or disturbance were observed within the canopy of Tree 9. Additionally, two small excavations pits were observed adjacent to Tree 15 and 16 (Plate 4). Within the two small excavations pits, roots less than 75 mm in diameter had been severed (Plate 5).

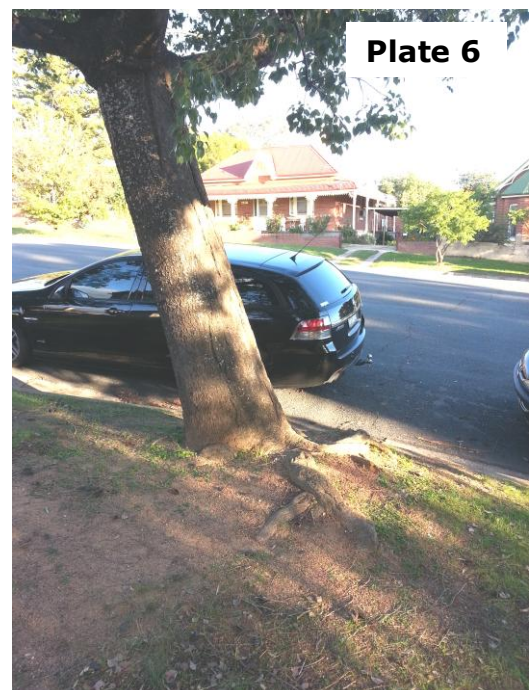
The majority of tree root plates were observed to be relatively undisturbed and interpreted to represent stable conditions. However, Tree 7 was observed to have an obvious trunk lean towards the east, and its root plate displayed signs of soil heave and root displacement (Plate 6). It was interpreted that the tree has likely experienced a primary root plate failure in the past, whereby roots on its western side have failed, but the remaining root system has been sufficient to maintain support for the tree. The tree was assessed to be structurally stable at the time of assessment, indicating that the tree's root system has responded to the primary failure with the formation of new roots to provide support.

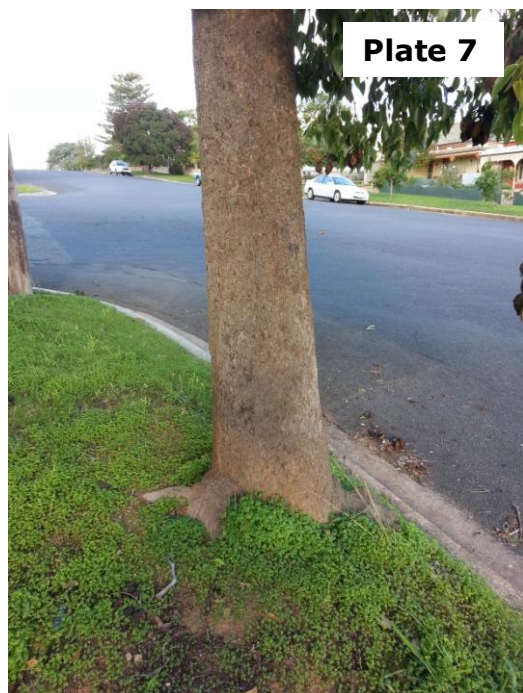
**Plate 7**

All trees displayed prominent root/trunk buttressing that has developed in response to prevailing climatic and environmental conditions, which would generally be indicative of extensive root development providing sound structural support. Due to the prevailing soil conditions, several trees displayed extensive buttressing (e.g. Plate 7 – Tree 2) and surface root development (e.g. Plate 8 – Tree 9). Minor mechanical damage was observed to some buttressing and surface roots but no significant issues were identified.

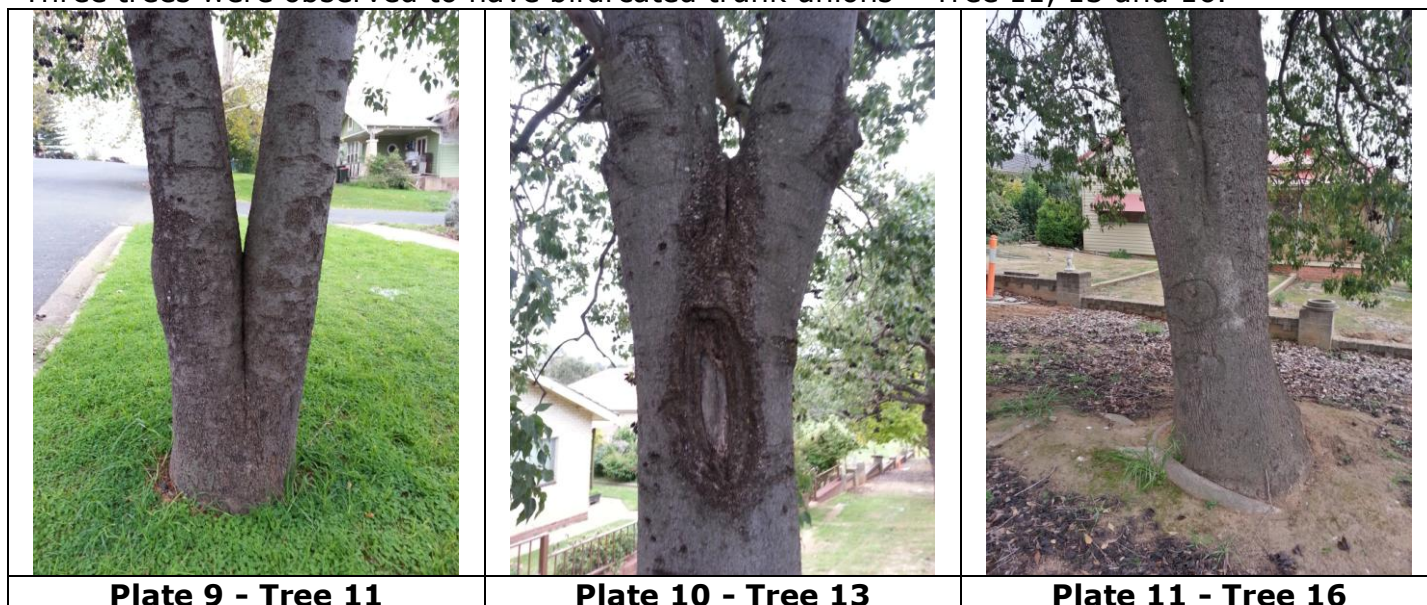
**Plate 9 - Tree 11**

The bifurcated unions of Tree 13 and 16 were observed to be structurally stable, with only minor bark inclusion and swelling evident. The bifurcated union of Tree 11 was observed to be tight, with obvious trunk deformation occurring. The trunk structure of Tree 11 was assessed to be structurally stable at the time of assessment; however it is acknowledged that issues with its structure may develop in the future that may necessitate intervention works (e.g. cabling or bracing).

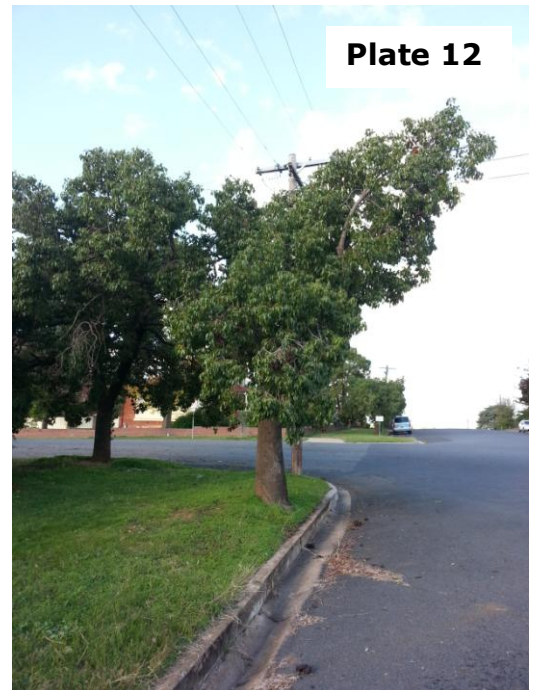
**Plate 12**

Tree 1 – 14 are located directly beneath low voltage power lines. Consequently, their canopies have been significantly pruned to ensure that appropriate clearance is maintained to these electrical assets (e.g. Plate 12 – Tree 2). The resultant canopy structure of these trees has been degraded, but all were assessed to be structurally stable.

- c) The trees are recognised to have heritage significance and as such their management should reflect their value. The presence of the low voltage power line is significantly affecting the canopy habit of most of the trees as their canopies are cyclically pruned to ensure that appropriate clearances to these electrical assets are maintained. Cyclic pruning requires removal of canopy within the legislated clearance zones, and additional clearance to accommodate growth that will occur between pruning cycles.

ENSPEC identifies that the best way to improve the canopy structure of these trees is to minimise their requirements for pruning. This can best be achieved by reengineered to aerial bundle cable. However, it is acknowledged that reengineered to aerial bundle cable is likely to be cost prohibitive to Council. Therefore an alternative action would be to instigate an annual pruning cycle so as to reduce clearance requirements for these trees.

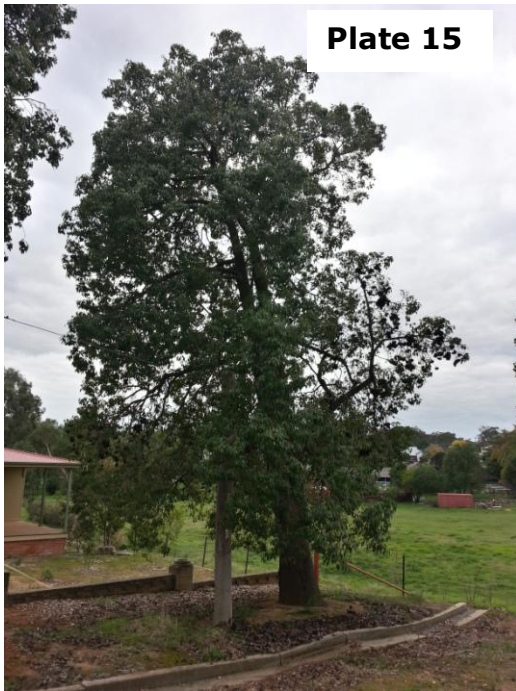
**Plate 15**

Given their landscape setting, all trees, except for Tree 9, displayed leaf size, colour, density and new season (internodal) growth typical for the species; generally indicative of good health (Plate 15). Tree 11 displayed obvious signs of tip dieback, leaf chlorosis (i.e. yellowing) and reduced canopy density (Plate 16). These observations are typical for trees that have been affected by root plate issues such as compaction and damage; both of which were identified as affecting this tree. The extent of canopy decline was assessed to be affecting the long term viability of the tree; but with favourable climatic conditions, and avoidance/minimisation of further root damage the tree has potential to recover.
