**VISUAL TREE ASSESSMENT (VTA) AND WRITTEN REPORT**

**LOCATION: DALLEY STREET JUNEE**

**COMPLETED FOR: JUNEE SHIRE COUNCIL**

**DATE: MAY 2014**

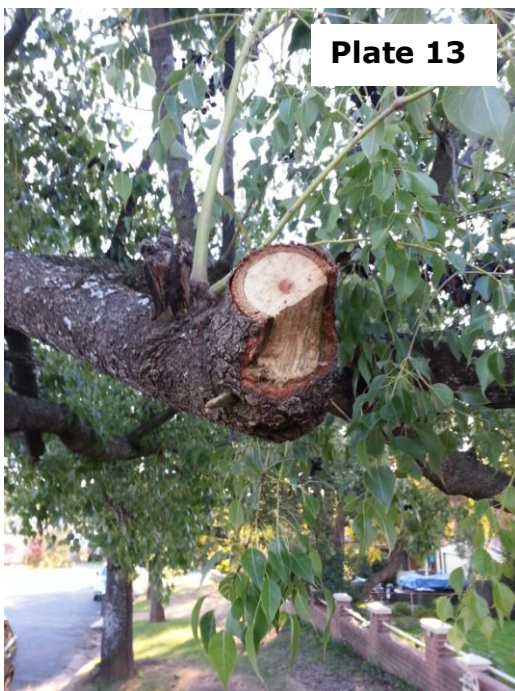
**Plate 13**

Recent canopy pruning was observed to have occurred on several of the assessed trees. It was identified that much of the pruning did not adhere to the current Australian Standard 4373-2007: Pruning Amenity Trees. Issues of poor pruning pertained to branch tears (Plate 13), flush cuts (Plate 14) and retention of stubs. While not a significant issue for the current structure of the trees, these observations highlight that pruning standards for Council and contractors should be improved and maintained.

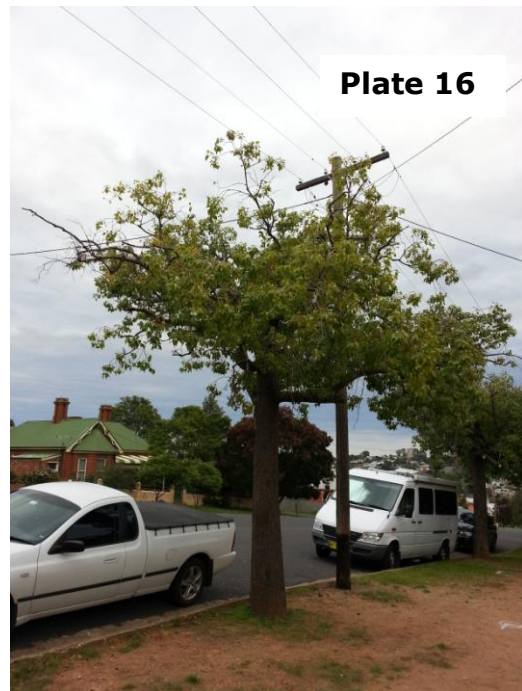
**Plate 16**

Given their landscape setting, all trees, except for Tree 9, displayed leaf size, colour, density and new season (internodal) growth typical for the species; generally indicative of good health (Plate 15). Tree 11 displayed obvious signs of tip dieback, leaf chlorosis (i.e. yellowing) and reduced canopy density (Plate 16). These observations are typical for trees that have been affected by root plate issues such as compaction and damage; both of which were identified as affecting this tree. The extent of canopy decline was assessed to be affecting the long term viability of the tree; but with favourable climatic conditions, and avoidance/minimisation of further root damage the tree has potential to recover.

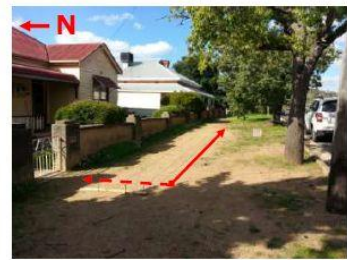
Tree 6, 7 and 8 – 16 Dalley Street Junee

Yellow dotted lines and boxes highlight roots.

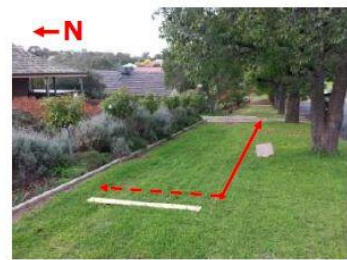
Tree 9 and 10 – 18 Dalley Street Junee

Yellow dotted lines and boxes highlight roots.
